IRON GIANT

A rare wrought-iron railway viaduct in the UK is being given a new lease of life for cyclists and pedestrians. **Helena Russell** reports

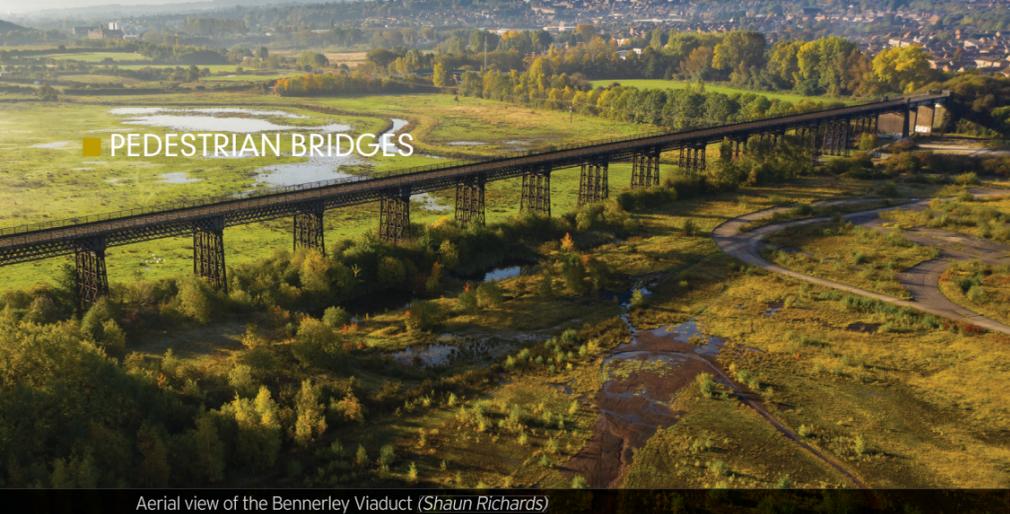
Aerial view of the Bennerley Viaduct (Shaun Richards)

What makes the viaduct notable in heritage terms is not just its rarity, but the fact that it was designed as a bespoke lightweight alternative to a masonry viaduct, intended to reduce the loading on the honeycombed, former mining land that it had to cross. The wrought iron structure has 15 piers and 16 spans supported on brick pier bases; it survives almost unaltered, with none of its structural characteristics modified or obscured by subsequent work. Four large cast iron base plates rest on top of each of the pier bases, and these support 12 wrought iron columns which make up each pier. These hollow columns, which are formed of riveted wrought iron quarter sections, are kept in position by horizontal and diagonal bracing elements tensioned using cotterpins. The lattice girders along each edge of the viaduct deck support 526 transverse iron troughs which contained

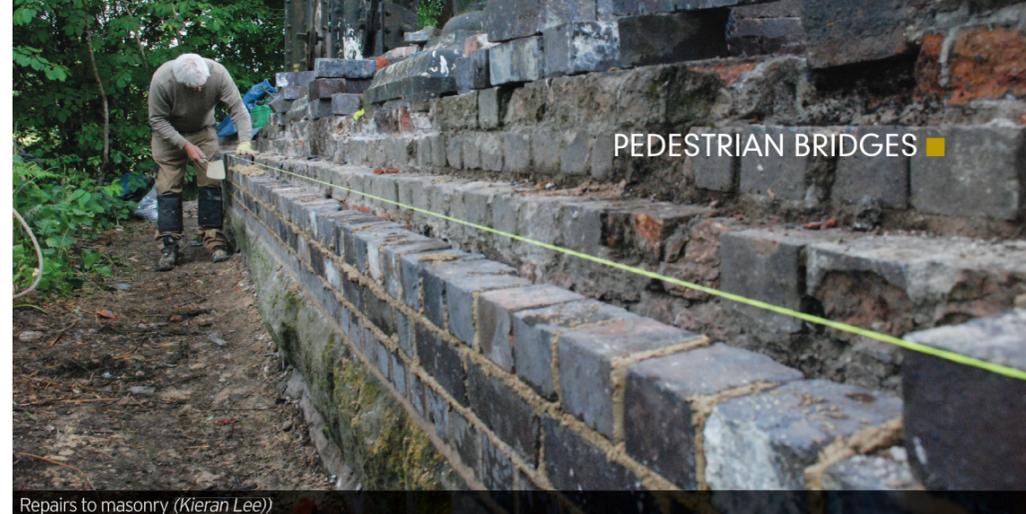
Repairs to masonry (Kieran Lee)

Many of the missing copings from the abutment walls were uncovered by volunteers clearing ground-level vegetation, and around 1,000 bricks were also gathered from the site for reuse. Deck-level hopper heads, which are part of a drainage system (added after the bridge was built), were loose, and many of the downpipes had also been lost. Entirely removing the system eliminated the risk of them falling off and as Weir

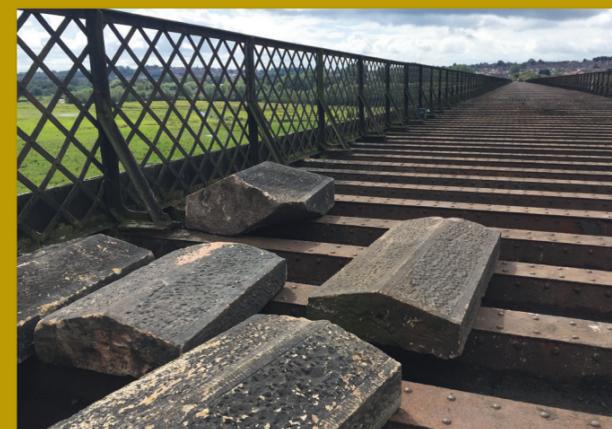
Coping stones (Helena Russell)
