# Restoring the fabric of a textiles landmark

Priestley faced the unknown when it set about converting a listed building with heavily constrained planning permission into a mixed-use scheme

## PROJECT REPORT HELENA RUSSELL

<b>Project</b> Conditioning House
<b>Client</b> Priestley Homes
<b>Contractor</b> Priestley Construction
<b>Architect</b> Priestley Design
<b>Structural engineer</b> Dunster Consulting
<b>Building control</b> Bureau Veritas UK
<b>M&amp;E consultant</b> Troup Bywaters & Anders
<b>Fire consultant</b> Leodis Consultants
<b>Start date</b> May 2019
<b>Completion date</b> December 2020 (pre-coronavirus schedule)

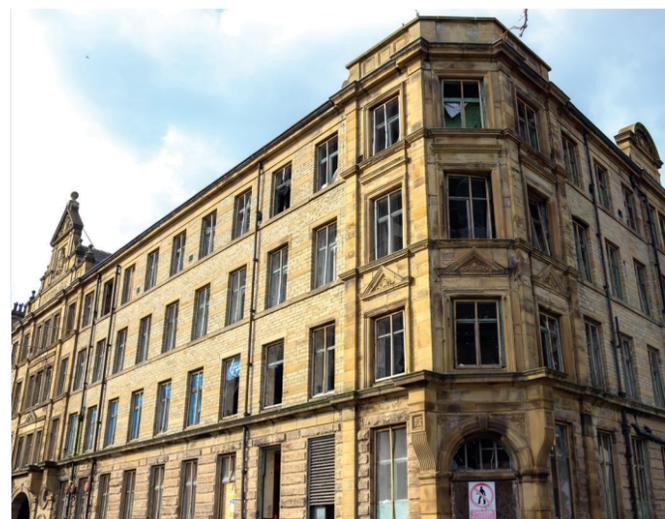
Steel beams replace or strengthen the floor and roof beams at strategic locations. These are more complex to install than the wooden beams due to the

Douglas Fir beams replace the Parana pine originals, which were designed to hold heavy wool bales and machinery.

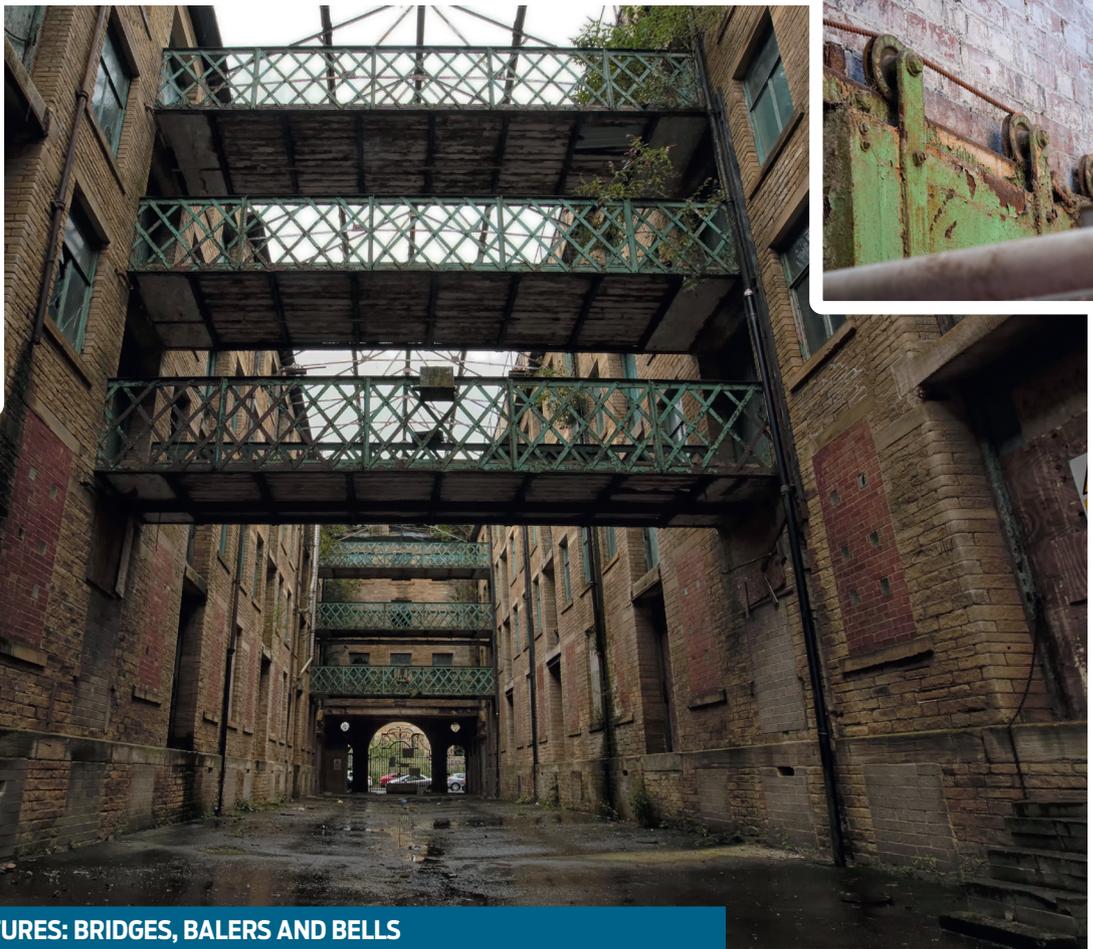
Retaining and restoring heritage features in the building – even when not required by planning conditions – is encouraged by the developer. The most obvious aspects are the six steel link bridges that connect the two buildings across the central atrium (above); these will be refurbished and the lattice parapets adapted to meet building regulations. Half of each bridge will provide external space for each of the 12 apartments that adjoin them (see top left).
